Gods Grace - Damage Disclosure

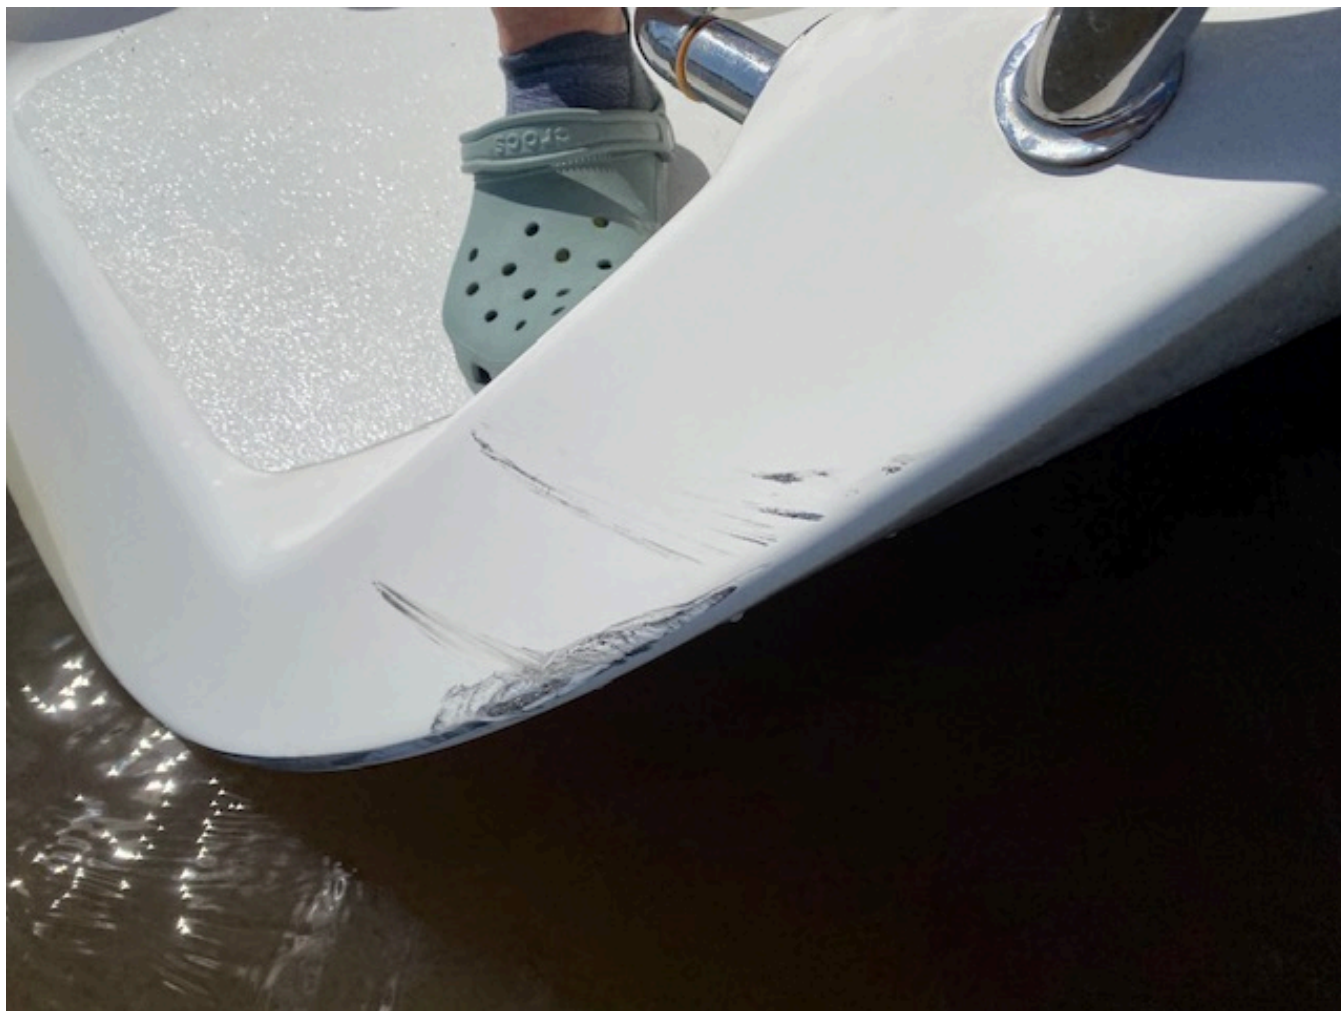
Photo: starboard sugar scoop, April 2023.

Surface rash on the outside corner of the starboard sugar scoop following the impact described on page 1. No hull penetration or water intrusion. Repaired at St. Augustine Marine Center.

After the repairs were completed and everything was reinstalled, I hired a professional company at a cost of \$13,000 to have the vessel completely buffed, waxed and polished.

I also had the entire Bimini Top sanded down fully by the yard and re-gelcoated.
